# Mobile Intel® Pentium® 4 Processor - M

## Specification Update

*April 2004*

Document Number: 250721-022

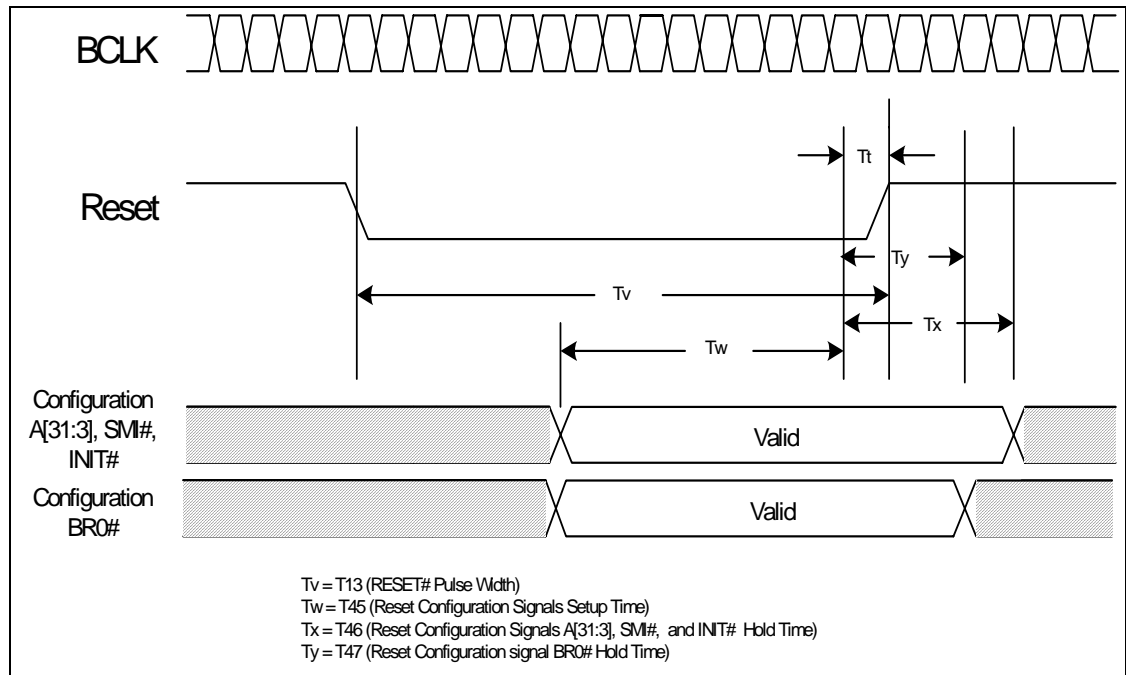
**Figure 13. System Bus Reset and Configuration Timings**

The BR0# maximum hold time has changed to 2 BCLKs. This change will be shown in the “System Bus AC Specifications (Reset Conditions)” table and “System Bus Reset and Configuration Timings” figure of the *Mobile Intel® Pentium® 4 Processor - M Datasheet*. This change will be incorporated in the next revision of the datasheet.
